**REMOVAL PROGRAM  
PRELIMINARY ASSESSMENT/  
SITE INVESTIGATION REPORT  
FOR  
TURKEY BROOK SITE  
OAKVILLE, LITCHFIELD COUNTY, CONNECTICUT  
9 OCTOBER 2013 THROUGH 19 FEBRUARY 2014**

Weston Solutions, Inc.  
Region I  
Superfund Technical Assessment and Response Team III (START)  
3 Riverside Drive  
Andover, MA 01810

March 2014

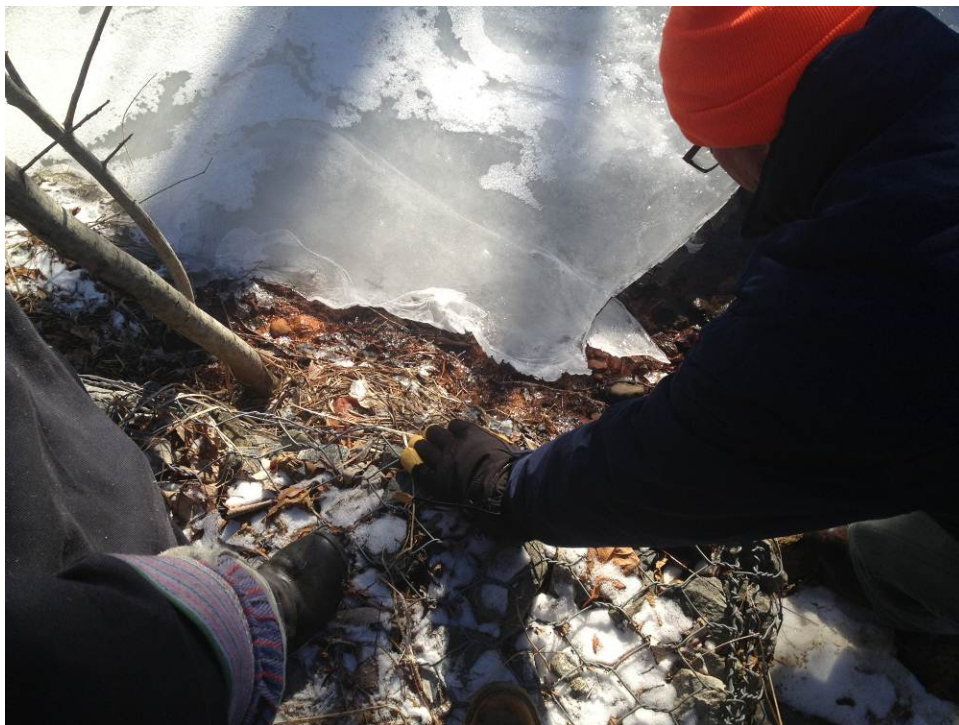
**SCENE:** View of personnel inspecting areas on northern banks of Turkey Brook, upstream of the spill area at the Quality Automatics, Inc. building.

TMC personnel showed START member Sharp and OSC Bzenas three areas where oil sheens were observed in the past from leachate breakouts originating in the northern banks of Turkey Brook, upstream of the spill area at the QAI building. The oil sheens were not visible due to a large amount of ice in the brook. OSC Bzenas decided not to collect any surface water samples from these locations at that time.

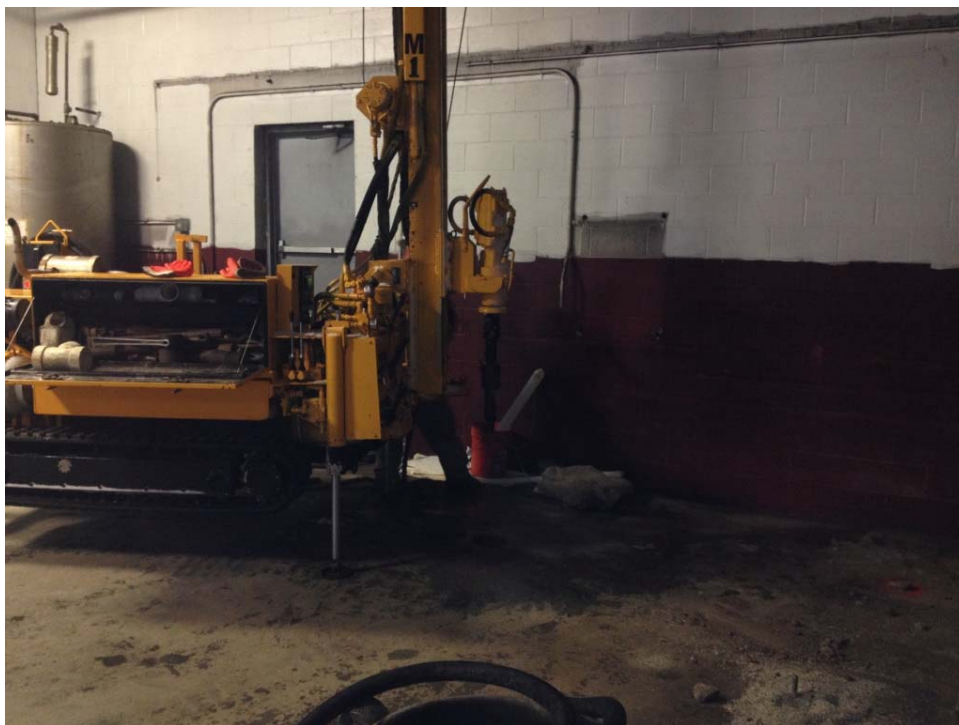
**SCENE:** View of the drill rig staged and being prepared to advance borings inside the Quality Automatics, Inc. building.
